CASE STUDY

Rock Catch Fence Miami Beach Queensland

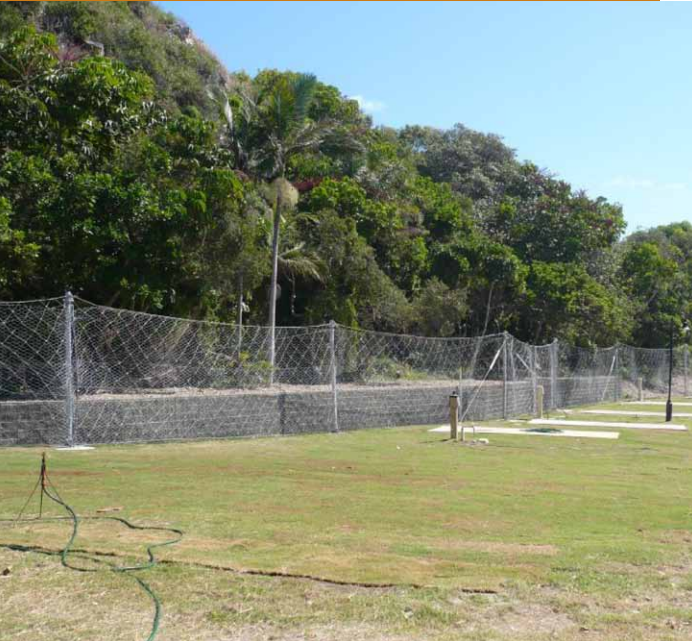
Due to lingering concerns that some debris or rocks on the steep face of the headland could be dislodged by severe weather or human activity the local authority acted to protect the caravan park area from this possibility by installing a purpose designed Rock Catch Barrier. More often seen in Europe where they are mostly deployed in alpine regions, the theory and practice is the same, i.e. the capture of mobile rocks and the significant reduction of risk of damage to people and property.

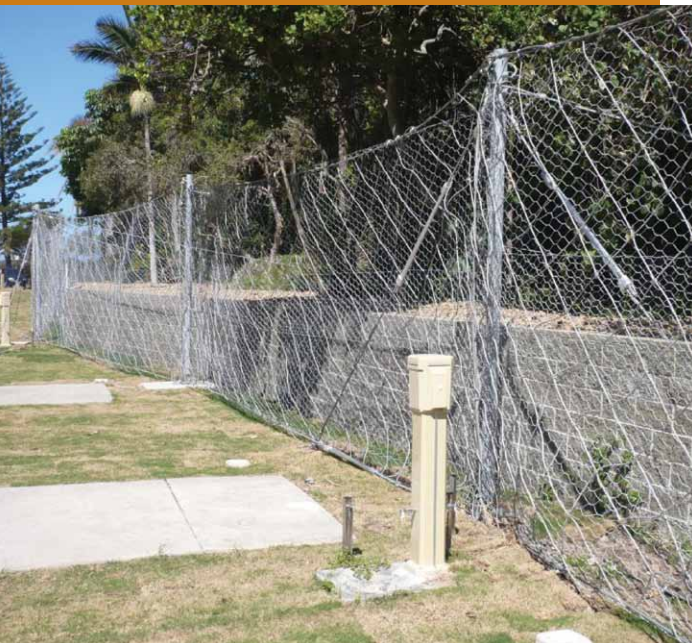
The barrier selected by the local authority is a proprietary system offered by Maccaferri Pty Ltd. The whole system was installed to strict specifications by Concrib.

These types of barriers are usually rated by the amount of energy absorption they are capable of. This particular design at Miami is rated at 500 kilo-Joules. As an example, this equates roughly to the ability to arrest a one tonne boulder traveling at 100kph. Some barriers used in the alpine regions of Europe are rated at ten times this – 5000kJ !!!
